CRYSTAL LAKE DAM

NH 00269

PHASE I INSPECTION REPORT NATIONAL DAM INSPECTION PROGRAM

NOVEMBER 1978

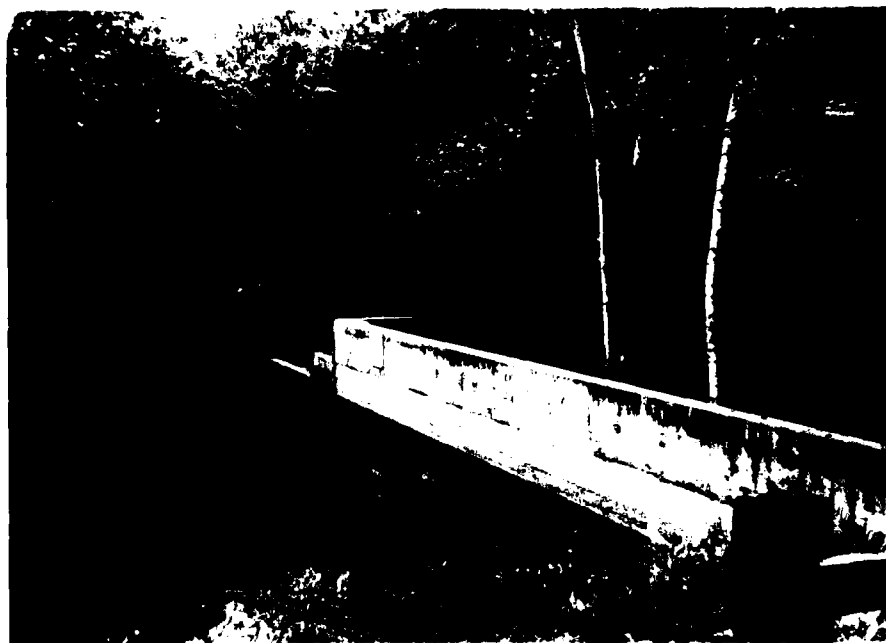
PHOTO NO. 6 - Close-up view of dam from right abutment.
